Structural repair of Careva Ćuprija Bridge in Sarajevo

Professional paper

Structural condition and repair of the Careva Ćuprija Bridge in Sarajevo is presented in the paper. This historic structure has been exposed to various atmospheric influences during its use, and also to significant traffic load for which it was not initially designed, which has ultimately resulted in degradation of its structure. To enable continued functioning of this bridge its structure must be repaired taking into account the fact that the bridge was proclaimed a national monument of Bosnia and Herzegovina on 11 March 2009.

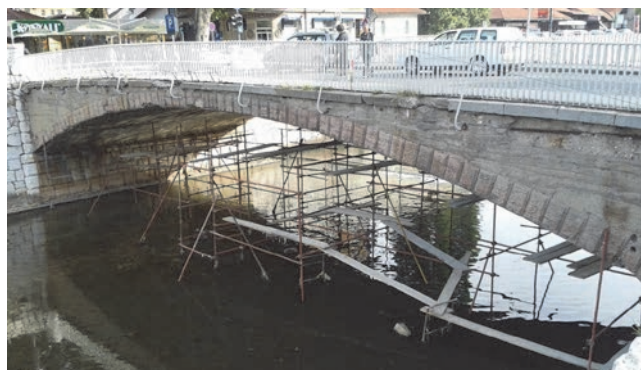
Figure 5. Careva Ćuprija Bridge with scaffolding during investigation works in 2015 [5]

Figure 5 shows the Careva Ćuprija Bridge with scaffolding under the bridge during investigation works conducted in 2015. It can be seen that some changes were made on the bridge regarding the pedestrian railing, and that bridge lighting was removed.

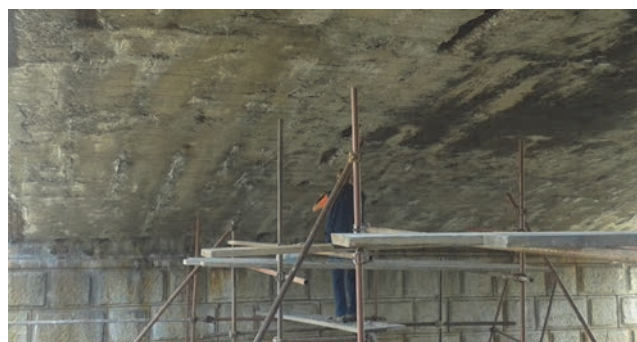
After removing some concrete from the bridge arch, it was established that the bridge intrados is reinforced with rigid reinforcement consisting of 2L sections measuring 60x60x4 mm (20 sets in total), as shown in Figure 6.

Figure 6. Location of rigid reinforcement

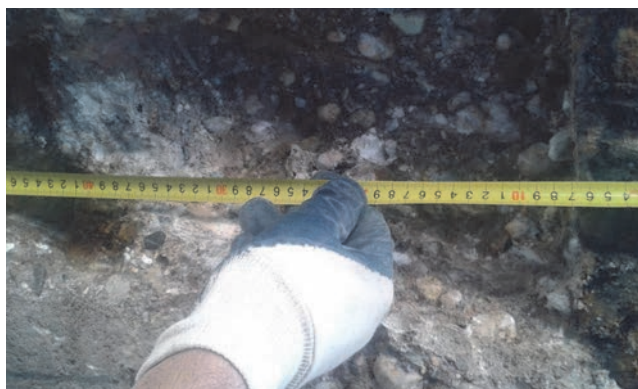
Figure 7 shows the position of the reinforcement that is arranged in the transverse direction at approximately every 45 cm to 50 cm intervals, and extends along the entire length of the bridge.

Figure 7. Rigid reinforcement spacing

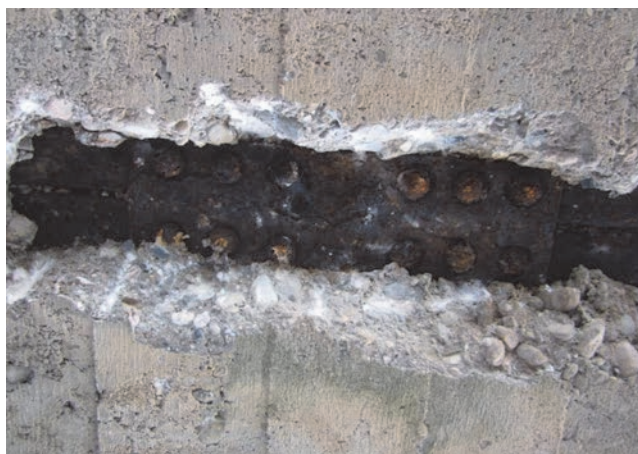
The rigid reinforcement was placed along the entire span of the bridge (Figure 6) with connections at four places. Figure 8 shows rigid reinforcement connection points. The rigid reinforcement connection was realized using a steel plate about 6 mm thick, with a set of six rivets on each side. The steel plate measures 46x13 cm and it is approximately 6mm in thickness. Rivets are spaced at 6 cm intervals. Inner spacing between the rivet sets is 13.5 cm, while the distance from the edge of the steel plate to the first (last) rivet is 4.5 cm. The steel corrosion and scaling was registered on the steel plates used as connections for rigid reinforcement.

Figure 8. Rigid reinforcement connection

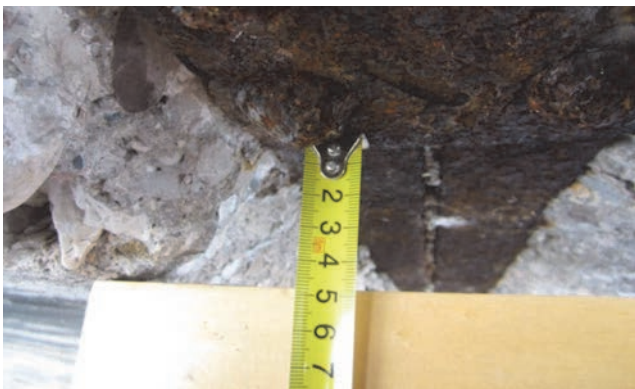
Figure 20. Thickness of concrete cover

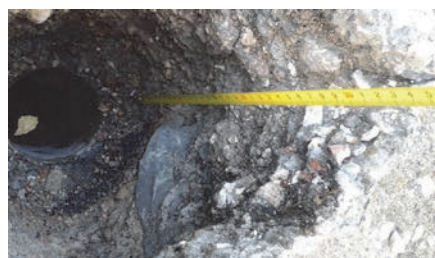
Figure 24. Waterproofing tar layer

A waterproofing tar layer ranging from 5 to 8 mm in thickness was found on top of the extrados (Figure 24).

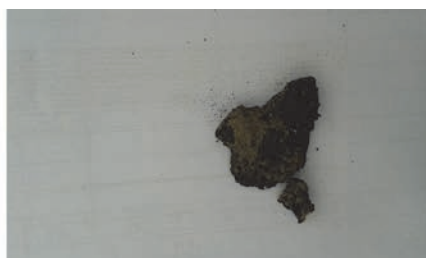
Figure 25. Steel hardness testing

Steel hardness was tested on the site using the POLDI method. The testing of steel hardness of the rigid reinforcement located on the intrados of the bridge is shown in Figure 25. Based on testing conducted on rigid reinforcement 2L 60 x 60 x 4mm, the steel can be classified as steel class Č 0545 according to JUS standards (according to EN 10027-1 E295, and DIN St 50-2), with the tensile strength of 470 N/mm², and the yielding strength of 285 N/mm².

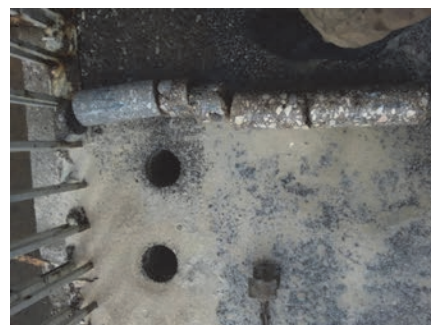
Figure 26 shows one of the samples extracted at the crown of the bridge and a sample taken in 2007, so that the quality of concrete can be compared.

Figure 26. Concrete samples

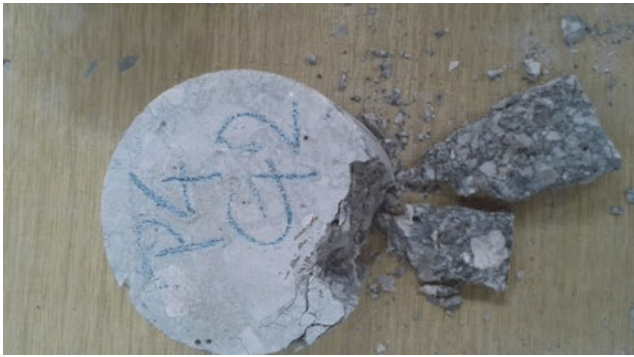
The analysis of P4 samples has revealed that a different type of concrete was used (Figure 28), and that it is a well structured factory-mixed concrete with dolomite aggregate, most probably originating from the post-war decades of the past century, or from this century. These data

cannot be taken into account when calculating the current class of concrete from the bridge arch because it represents a "new" concrete that was obviously used in bridge repair some ten to fifteen years ago. This concrete sample is completely different from the other samples regarding its structure, where in all other samples river aggregate and another type of cement has been used.

Figure 28. Sample from sidewalk (P4)

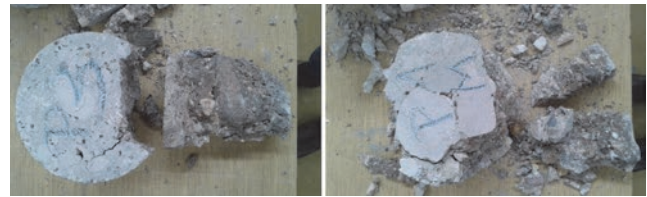
All other samples are of different structural composition involving the use of river aggregate (Figure 29) and cement that has, unlike cements produced since the mid twentieth century, a conspicuous change in cement stone colour (darker and lighter shades of brown).

Figure 29. Samples from other parts of the structure

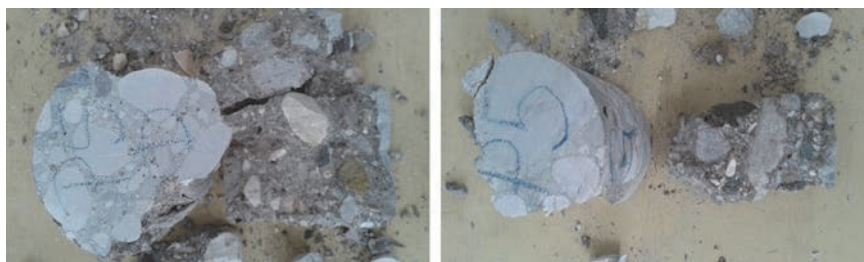
occurs at the location where these samples were extracted. Due to the soft water seepage, capillaries are being filled, which is manifested by concrete coagulation and increase of density in hardened state. The values of density (2142 kg/m³ and 2134 kg/m³) and compressive strength on the cube (37.0 MPa and 39.5 MPa) greatly deviate from all other similar results [8]. Water seepage through concrete is characterised by uneven filtration: the number of filtration channels is the greatest at the beginning of the filtration path, next to concrete surface exposed to pressure. Blockage of filtration occurs due to hydrolytic decomposition of cement stone and swelling of colloidal compounds (mostly calcium hydrosilicate). The process of leaching is significantly slowed down only if the layer depleted and weakened by leaching of lime, which is formed on the surface of concrete, does not fall apart due to mechanical or hydraulic effects (Figure 30). Significant corrosion of concrete can be observed on all samples (Figure 31).

Figure 30. Samples P5 D and P5 G

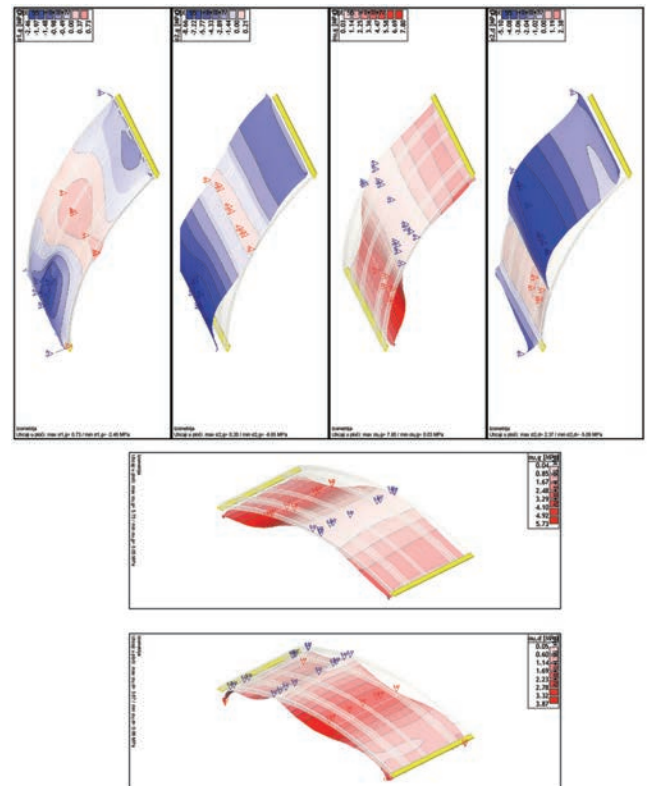
Figure 33 shows the stress state for the load combination +II+III+IV – V300+V300 which was adopted as the structure can not be strengthened using greater load while respecting at the same time the requirement to make as little interventions on the structure as possible.

Figure 33. Stresses for load combination with load vehicles V300 + V300 - existing structure: I - dead weight of the structure, II - weight of the fill and bulk material, III - load from top layers and railing weight, IV - type of live load

It was established according to calculations that the intrados of the bridge structure will be strengthened with reinforcement meshes (MA 500/560) Q524 and with sprayed concrete class

MB 20 10 cm in thickness. The extrados will be reinforced with meshes (MA 500/560) Q524 and with sprayed concrete class MB 20 approximately 5 cm in thickness. Shotcrete is traditionally used to increase the arch thickness in order to increase the carrying capacity, and to stabilize and protect structures exposed to atmospheric conditions. A large number of Victorian masonry bridges and arch structures in England were strengthened in this way [14].

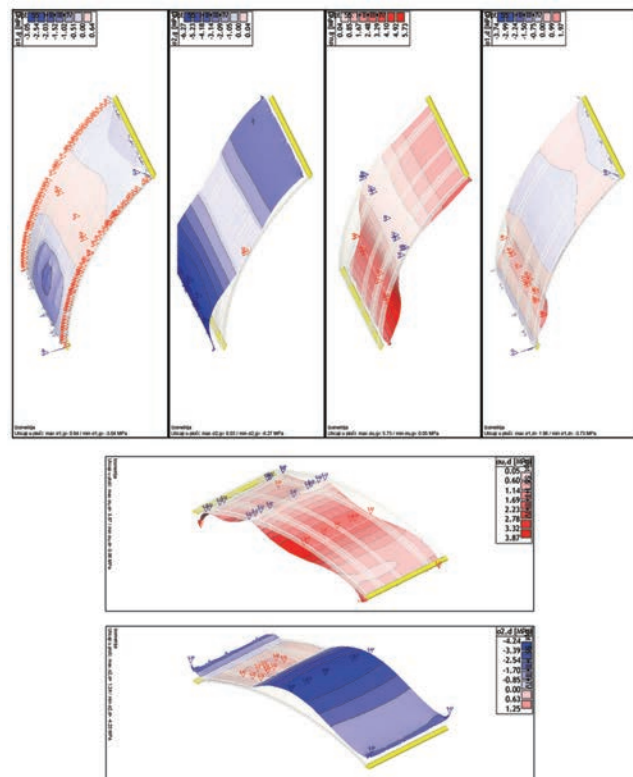
Figure 34. Stresses for load combination with load vehicles V300 + V300 - rehabilitated structure

Finally, an analysis of the rehabilitated structures was done in accordance with the investor's approval. The stress state of the arch is shown in Table 8 and Figure 34. Table 9 shows the amount of reinforcement needed to take over the tensile stresses.
